Technical Service Bulletin

Subject: WHISTLING NOISE FROM FRONT DOOR WINDOW GLASS OR WINDSHIELD WHEN DRIVING AT HIGHWAY SPEED	Bulletin No.: 09-028/21
	Last Issued : 12/17/2021

2017-2021 CX-5

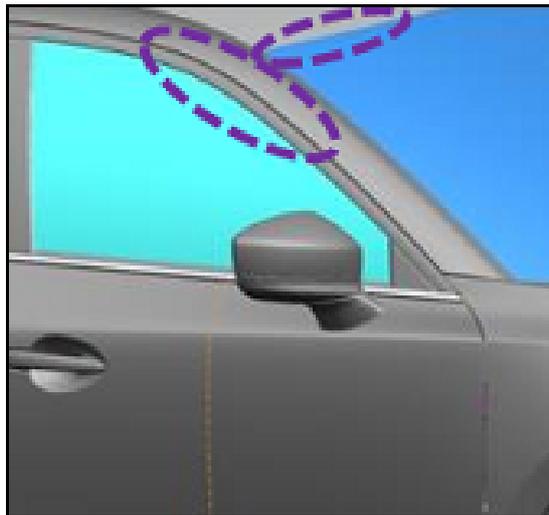
Some customers may complain about a whistling noise heard from the top of the A-pillar area and/or the top of windshield area when driving at highway speeds.

When driving under the following conditions, a negative pressure is generated on the doors and the windshield pulling them outward and resulting in weatherstrip vibration.

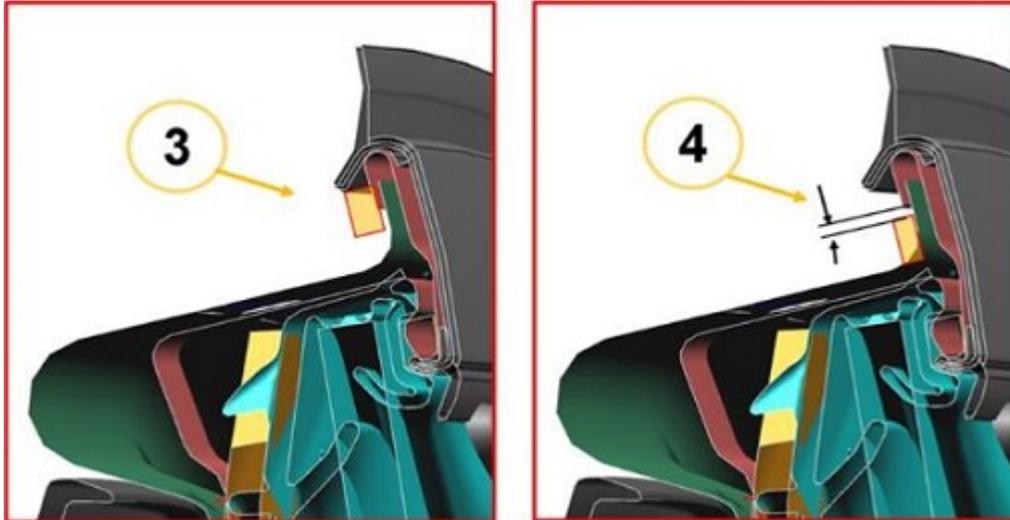
Examples of Poor Pad Attachment (3 and 4)
